US Army Corps of Engineers

HURRICANE KATE STORM SURGE DATA

Report 5

Coastal Engineering Research Center

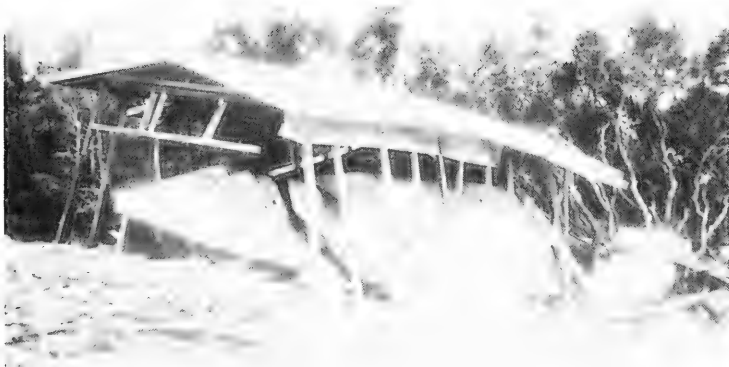
Photo 14. Trailer destruction between East Point and Carrabelle, Fla.
